Technical Service Bulletin

SUBJECT:			No: TSB-10-13-002
DTCs P0657, P1590, U0101, U0100, P0201 – P0206 & POSSIBLE NO START (U.S. ONLY)			DATE: January, 2010
			MODEL: See Below
CIRCULATE TO:	<input type="checkbox"/> GENERAL MANAGER	<input checked="" type="checkbox"/> PARTS MANAGER	<input checked="" type="checkbox"/> TECHNICIAN
<input checked="" type="checkbox"/> SERVICE ADVISOR	<input checked="" type="checkbox"/> SERVICE MANAGER	<input checked="" type="checkbox"/> WARRANTY PROCESSOR	<input type="checkbox"/> SALES MANAGER

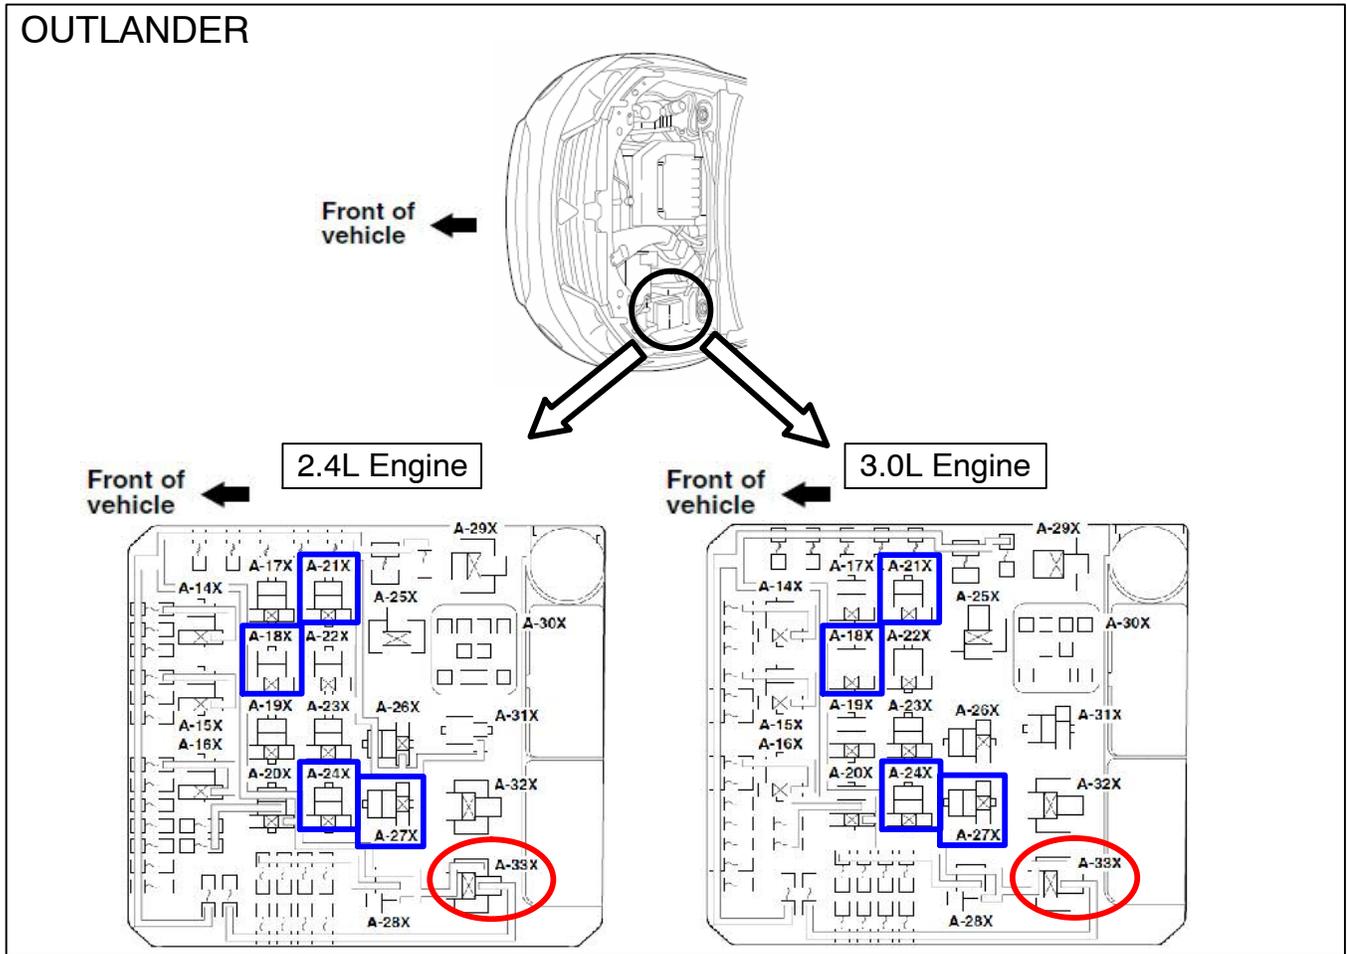
OUTLANDER

Connector No.	Name	Correct Part no.	Remarks
A-18X	A/T control relay (3.0L Engine)	8627A024	Shown as

CVT Control Relay (2.4L Engine)		
A-21X	Throttle actuator control motor Relay		
A-24X	Injector Relay		
A-27X	Starter Relay		
A-33X	MFI Relay	MR400709	Shown as

- Turn the ignition switch to the LOCK (off) position.
- Locate the relay box inside the engine compartment and open the cover.
- Refer to the illustrations on pages 2 through 4 of this TSB and replace relays as follows:
 - Vehicles equipped with A/T or CVT – Replace the Injector Relay, Starter Relay, Throttle Actuator Control Motor Relay, AT/CVT Control Relay with p/n 8627A024, and replace the MFI relay with p/n MR400709.
 - Vehicles equipped with M/T or SST – Replace the Injector Relay, Starter Relay, Throttle Actuator Control Motor Relay with p/n 8627A024, and replace the MFI relay with p/n MR400709.

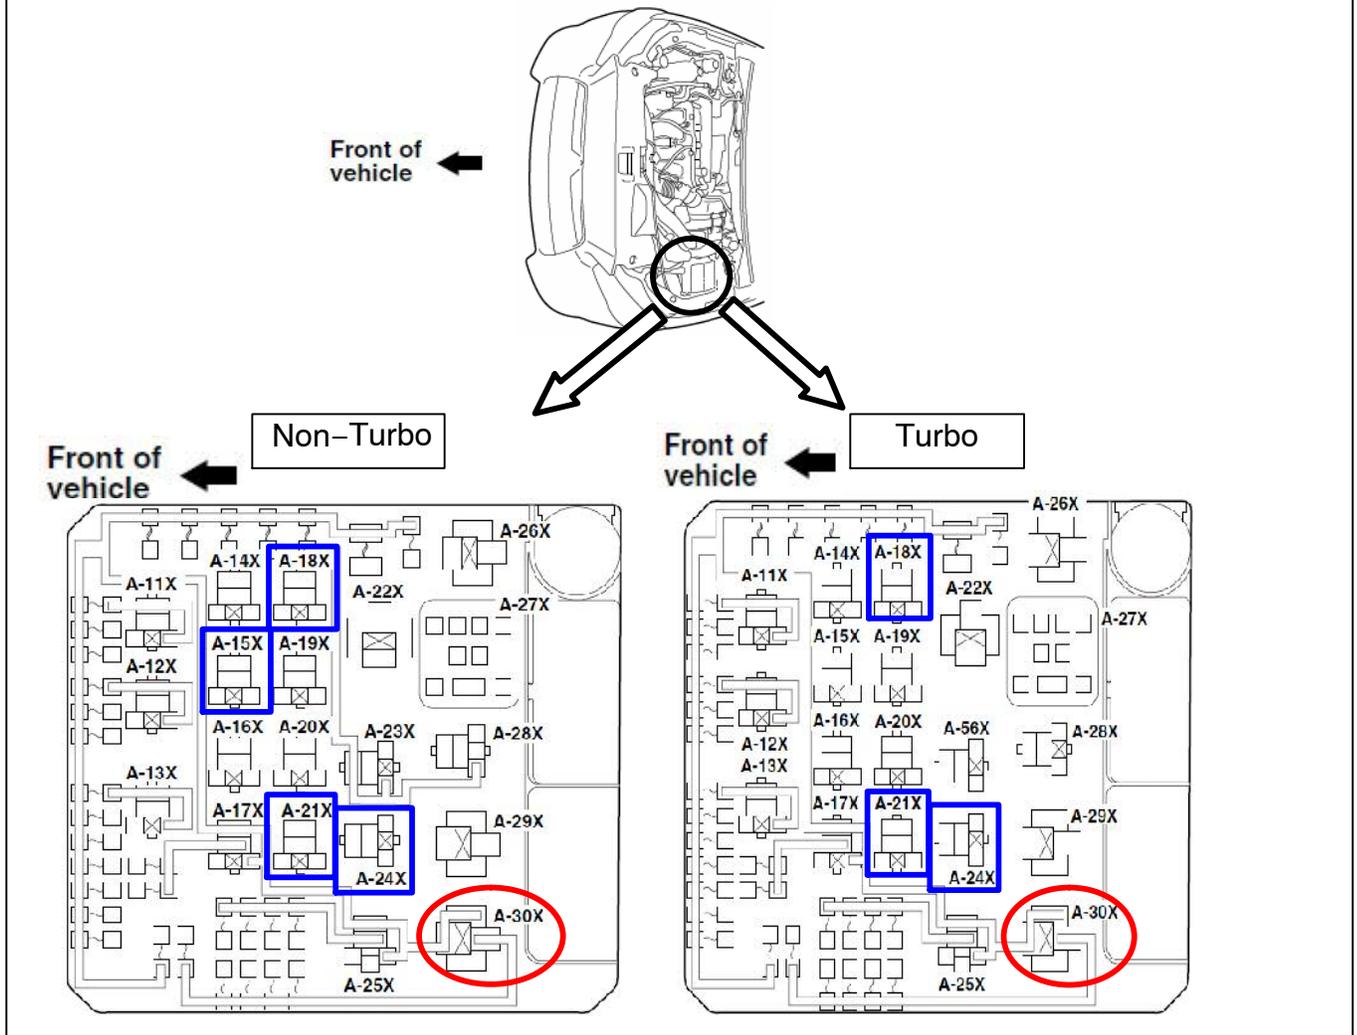
LANCER and LANCER SPORTBACK			
Connector No.	Name	Correct Part no.	Remarks
A-15X	CVT control relay	8627A024	Shown as

A-18X	Throttle actuator control motor Relay		
A-21X	Injector Relay		
A-24X	Starter Relay		
A-30X	MFI Relay	MR400709	Shown as

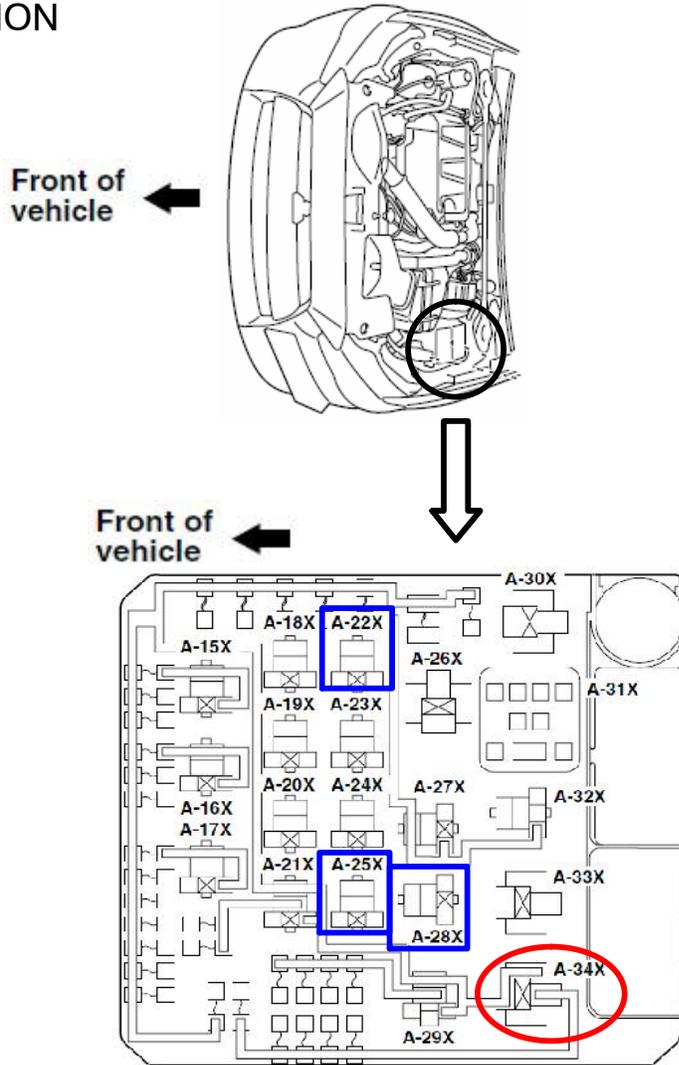
LANCER EVOLUTION

Connector No.	Name	Correct Part no.	Remarks
A-22X	Throttle actuator control motor Relay	8627A024	Shown as

A-25X	Injector Relay		
A-28X	Starter Relay		
A-34X	MFI Relay	MR400709	Shown as

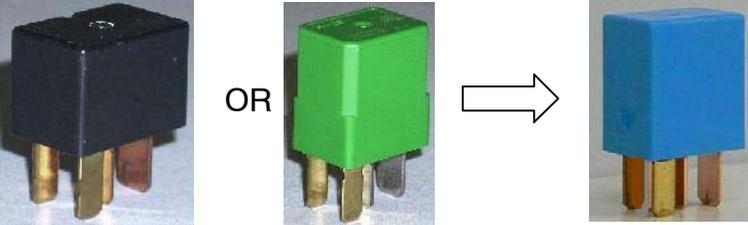
Part Number	Identification
8627A024 (Relay)	<p><u>Control relays</u> Replace Black (p/n MR588567) or Green relay (8627A011) with a Blue relay (p/n 8627A024).</p> <p>p/n MR588567 p/n 8627A011 p/n 8627A024</p>
